Digital Monument Reconstruction in Architectural Studies: Synthesis of Research on the Previously Unknown Form of the Palace in Łobzów (Cracow) from the Period of the Rule of John III Sobieski

Piotr Pikulski*

vol. 9, 2020, 2, pp. 97–110

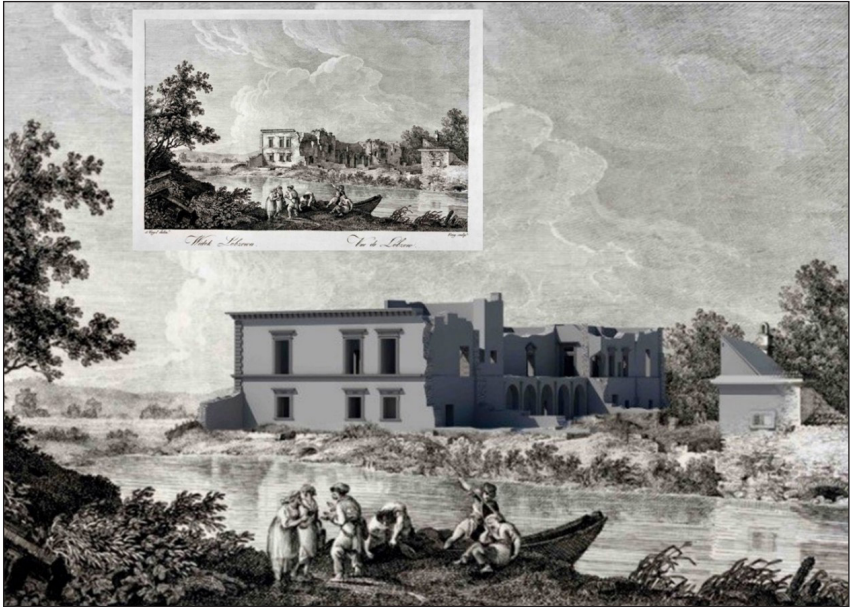
Figure 1: Insertion of the digital reconstruction of the Łobzów palace ruins as at the start of the nineteenth century onto the print by Jan Zachariasz Frey and Zygmunt Vogel; authors: Piotr Pikulski, Maksymilian Szpyt.

The first iconographic source presenting the state of the palace after the Swedish Deluge is dated to the start of the nineteenth century. In 1809, Zygmunt Vogel and Jan Zachariasz Frey made a print depicting the Łobzów residence in a ruined state. It remained in this condition until 1802, when it became the property of Austrian authorities which commissioned an in-depth survey of the ruins and a design for its adaptive reuse as a Cadet School. The print by Vogel and Frey and the Austrian survey provided a basis for the building of a precise digital model of the residence's ruins.

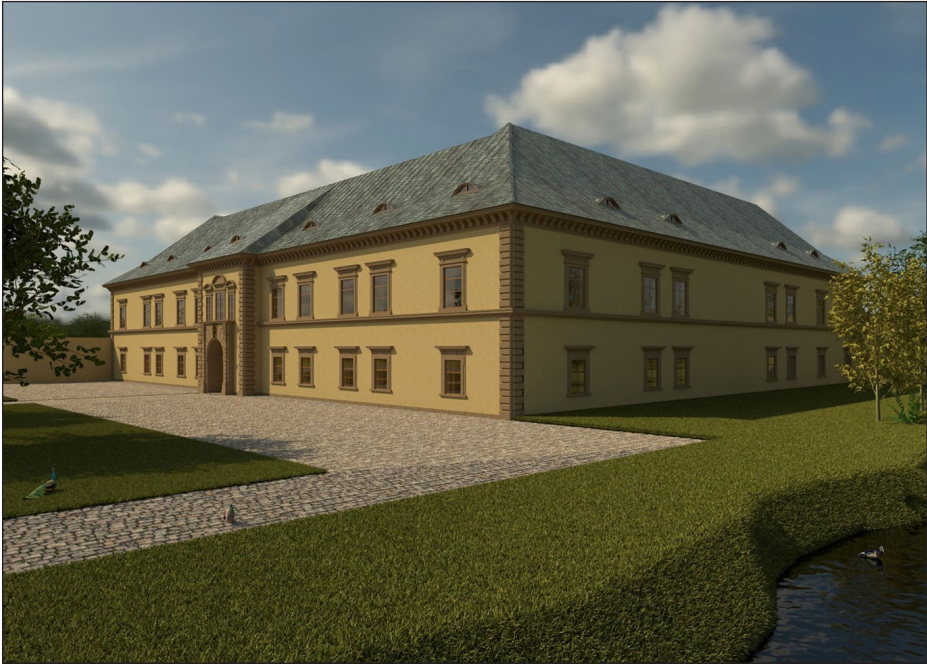
Figure 4: Reconstruction of the substance of the Łobzów palace after its remodelling by Władysław IV Vasa, the final known form of the palace before the damage inflicted by the Swedish army; author: Piotr Pikulski.

Discrepancies visible when comparing digital models of the Vasa-period form of the palace, the last state from before the Swedish Deluge that is known, and its nineteenth-century ruin, the first known state after its destruction by the Swedes, provide grounds for a theory that the palace could have been subjected to extensive remodelling between these two periods.

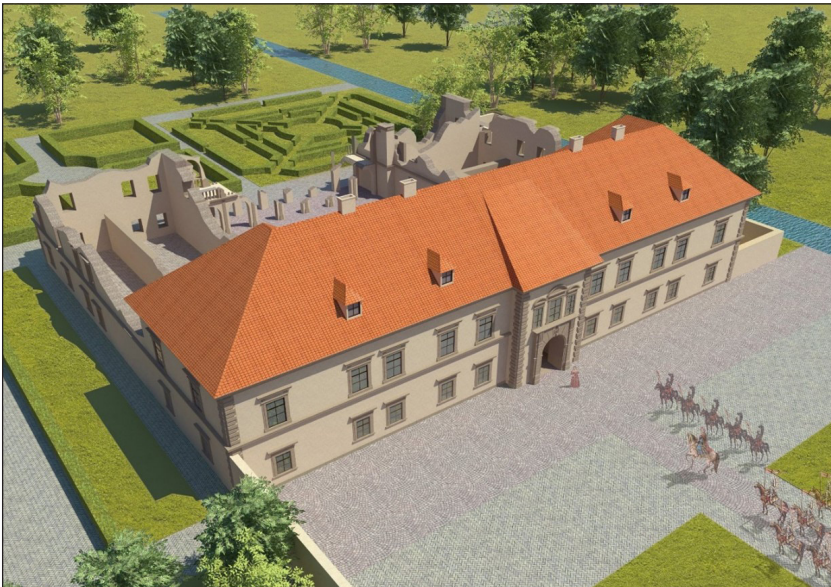
Figure 7: The Łobzów palace after its reconstruction by John III Sobieski, digital reconstruction of the probable state of the building's preservation ca. 1684, during the return of the king from the Battle of Vienna, view from the south, with the remains of the side wings and the arcade courtyard visible in the back; author: Piotr Pikulski.

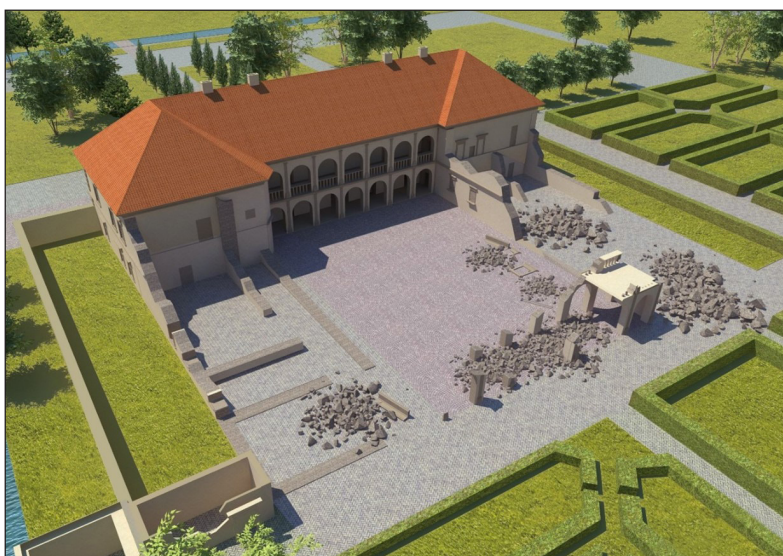
Figure 9: The Łobzów palace after its reconstruction by John III Sobieski, digital reconstruction of the probable state of the building's preservation from the final decade of the seventeenth century, after the gradual demolition of the remains of the eastern, western and the entirety of the northern wing so as to obtain materials that could be used in the construction of the Palace in Wilanów; author: Piotr Pikulski.
